**Flood Control Project Maintenance
Levee Inspections**
LMA District Cover Sheet
Spring 2017 Levee Inspection Results

Sutter Maintenance Yard East Levee Sacramento River

Spring 2017 Levee Inspection Results

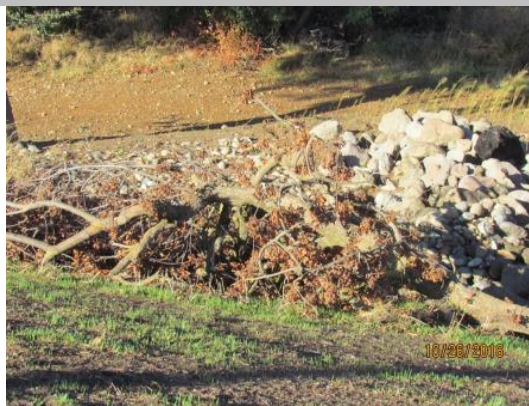
Photo 1 of 1 : SP_2017_ST0003_264_74_20170315_00020.jpg

LM Start	13.68	Rating **	M	Issue No.	74
LM End	13.68	Issue Type +	En	Location *	WS
Category	Earthen Levee			GPS Latitude/Longitude	
				Start	End
Item	Encroachments			39.310431 °	39.310431 °
				-122.012914 °	-122.012914 °
DWR ID	DWR_ST0003_01_f_2016_74				
Comment Code					
TR : Tree or limb					
Inspector Comment

View of a tree limb along the waterside slope.

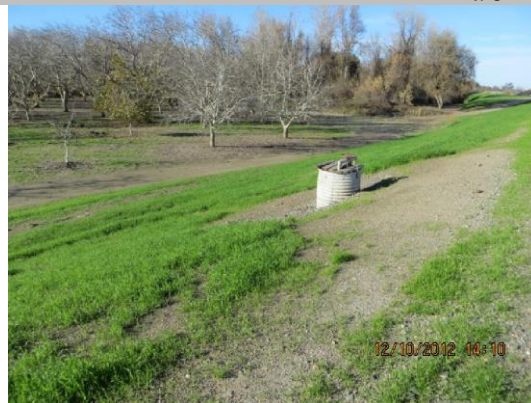
Photo 1 of 3 : UCIP_SP_2017_51750_47349.jpg

FS_ID:51750
DS_ID:17361
EP_NO: N/A
Repair Type: Non-Urgent
Crossing Status: Indicator Found
UCIP Comments: 4/20/2017 Abandoned- needs to be done properly. (DWR Sutter Yard- AFreitag)10/31/2016 Appears abandoned. WS pipe end buried. (DWR Sutter Yard- AFreitag)6/14/2016 WS pipe end was dug up for a internal camera inspection. The WS slide gate was sealed shut and would not open so the inspection was only done form the WS pipe end to the WS slide gate (33.1ft). The pipe showed some signs of heavy rusting but no visible holes or other signs of deterioration were found. After the inspection the WS pipe end was capped and reburied until further abandonment can be achieved.4/2/2015 Only CMP riser on WS. Pipe has been selected for internal camera inspection. Only CMP riser found on WS.7/2/2014 Same as last inspection.12/19/2013 Same as last inspection.7/23/2013 Same as last inspection.
FIELD_STRUCT_DESC: 24-inch corrugated metal drainage pipe through the levee, 16 feet below the crown, not found in 2015. Slide gate in a corrugated metal pipe (CMP) riser on the waterside (WS) end, found in 2015. [Additional Reference(s): DWR Levee Log, 2002. USACE Sacramento O&M Manual 136, March 1960 (HLM 13.92)].

Waterside view: CMP riser with slide gate

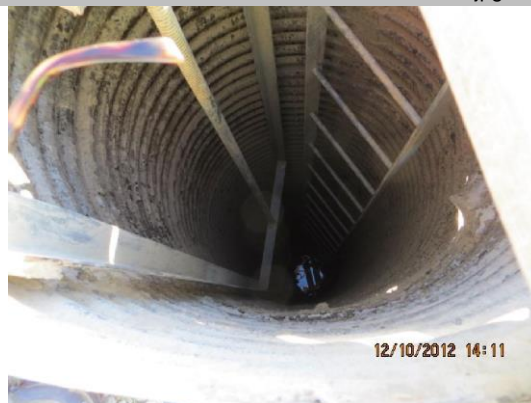
Photo 2 of 3 : UCIP_SP_2017_51750_47348.jpg

Waterside view: inside CMP riser

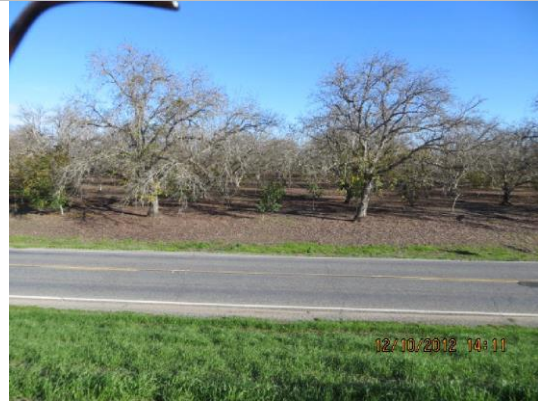
Photo 3 of 3 : UCIP_SP_2017_51750_47347.jpg

Comment Code					
Inspector Comment					
FS_ID:51750 DS_ID:17361 EP_NO: N/A Repair Type: Non-Urgent Crossing Status: Indicator Found UCIP Comments: 4/20/2017 Abandoned- needs to be done properly. (DWR Sutter Yard- A Freitag)10/31/2016 Appears abandoned. WS pipe end buried. (DWR Sutter Yard- A Freitag)6/14/2016 WS pipe end was dug up for a internal camera inspection. The WS slide gate was sealed shut and would not open so the inspection was only done form the WS pipe end to the WS slide gate (33.1ft). The pipe showed some signs of heavy rusting but no visible holes or other signs of deterioration were found. After the inspection the WS pipe end was capped and reburied until further abandonment can be achieved.4/2/2015 Only CMP riser on WS. Pipe has been selected for internal camera inspection. Only CMP riser found on WS.7/2/2014 Same as last inspection.12/19/2013 Same as last inspection.7/23/2013 Same as last inspection. FIELD_STRUCT_DESC: 24-inch corrugated metal drainage pipe through the levee, 16 feet below the crown, not found in 2015. Slide gate in a corrugated metal pipe (CMP) riser on the waterside (WS) end, found in 2015. [Additional Reference(s): DWR Levee Log, 2002. USACE Sacramento O&M Manual 136, March 1960 (HLM 13.92)]. FS Date: 5/1/2017 10:32:09 AM

Landside view: overview- across the county road

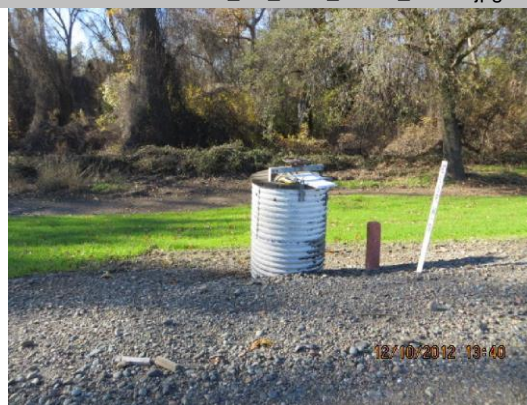
Photo 1 of 3 : UCIP_SP_2017_51752_47356.jpg

Comment Code					
Inspector Comment					
FS_ID:51752 DS_ID:17330 EP_NO: 9508 Repair Type: No Action Needed Crossing Status: Found UCIP Comments: 4/20/2017 Abandoned- needs to be done so properly. (DWR Sutter Yard- AFreitag)10/31/2016 Appears abandoned. WS pipe end buried. (DWR Sutter Yard- AFreitag)6/14/2016 Pipe was internally cleaned and camera inspected on 11/17/2015 by Nor-Cal Pipeline Services. Pipe section through levee is 86ft long and showed some signs of rusting but no visible holes or other deterioration was found. After the inspection the WS end was capped and reburied until further abandonment can be achieved.4/14/2016 Concrete box on LS cleared of sediment.4/2/2015 Same as last inspection. Concrete box on LS silted in. If abandoned it should be done so properly.7/2/2014 Same as last inspection.12/19/2013 Same as last inspection.7/23/2013 Same as last inspection. FIELD_STRUCT_DESC: 24-inch corrugated metal drainage pipe through the levee, 14 feet below the crown. Slide gate in a 36-inch corrugated metal pipe (CMP) riser on the waterside (WS) slope. Concrete distribution box on the landside (LS). (Automatic Board Order (ABO) issued as Permit No. 9508, 1974 - Jones). [Additional Reference(s): DWR Levee Log, 2002. USACE Sacramento O&M Manual 136, March 1960 (HLM 14.5)]. FS Date: 5/1/2017 10:34:48 AM

Waterside view: CMP riser with slide gate

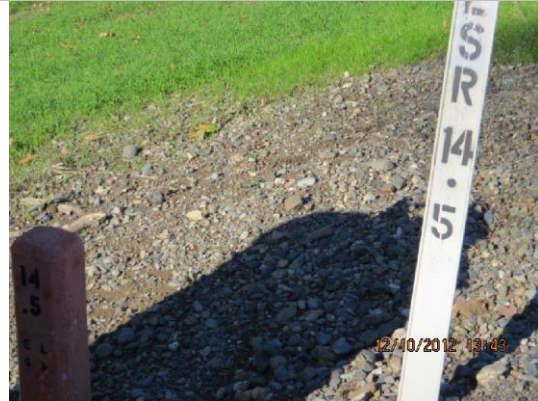
Photo 2 of 3 : UCIP_SP_2017_51752_47361.jpg

FS_ID:51752
DS_ID:17330
EP_NO: 9508
Repair Type: No Action Needed
Crossing Status: Found
UCIP Comments: 4/20/2017 Abandoned- needs to be done so properly. (DWR Sutter Yard- A Freitag)10/31/2016 Appears abandoned. WS pipe end buried. (DWR Sutter Yard- A Freitag)6/14/2016 Pipe was internally cleaned and camera inspected on 11/17/2015 by Nor-Cal Pipeline Services. Pipe section through levee is 86ft long and showed some signs of rusting but no visible holes or other deterioration was found. After the inspection the WS end was capped and reburied until further abandonment can be achieved.4/14/2016 Concrete box on LS cleared of sediment.4/2/2015 Same as last inspection. Concrete box on LS silted in. If abandoned it should be done so properly.7/2/2014 Same as last inspection.12/19/2013 Same as last inspection.7/23/2013 Same as last inspection.
FIELD_STRUCT_DESC: 24-inch corrugated metal drainage pipe through the levee, 14 feet below the crown. Slide gate in a 36-inch corrugated metal pipe (CMP) riser on the waterside (WS) slope. Concrete distribution box on the landside (LS). (Automatic Board Order (ABO) issued as Permit No. 9508, 1974 - Jones). [Additional Reference(s): DWR Levee Log, 2002. USACE Sacramento O&M Manual 136, March 1960 (HLM 14.5)].

Waterside view: levee mile marker

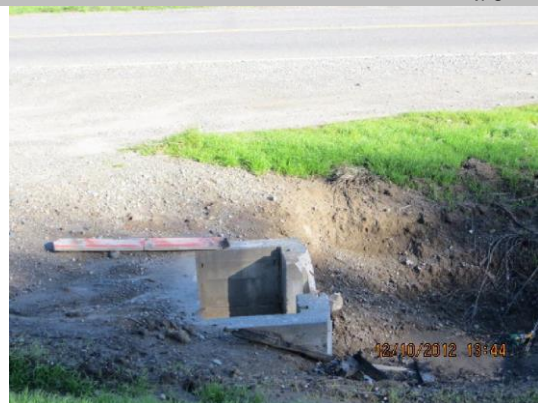
Photo 3 of 3 : UCIP_SP_2017_51752_47360.jpg

Landside view: overview of distribution box

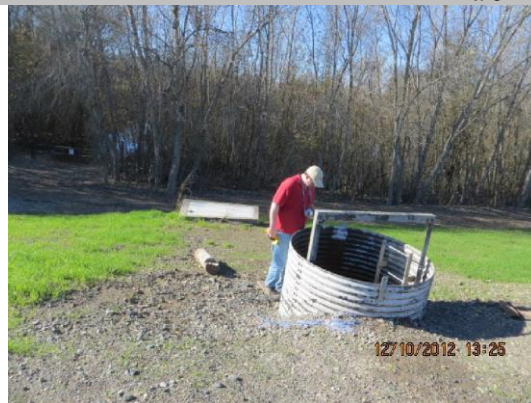
Photo 1 of 3 : UCIP_SP_2017_51753_47363.jpg

FS_ID:51753
DS_ID:17331
EP_NO: 1833
Repair Type: Non-Urgent
Crossing Status: Found
UCIP Comments: 4/20/2017 No leaky pipe marker present during this inspection but it appears that nothing has changed or was repaired since it was labled leaky in 2015. (DWR Sutter Yard- A/Freitag)10/31/2016 Leaky pipe marker was not present at inspection but nothing appears to have changed with this crossing. (DWR Sutter Yard- A/Freitag)6/15/2016 No changes made to this crossing. Leaky pipe marker still present.4/14/2016 Levee slightly caved in one side of surge box on WS4/2/2015 Leaks during high water. Distribution box plugged with cement concrete on LS. Other concrete box plugged with concrete on WS. New steel pipe (about 16 inch diameter) sleeved through CMP pipe. It is visible inside CMP riser.7/2/2014 Same as last inspection.12/19/2013 Same as last inspection.7/23/2013 Same as last inspection.
FIELD_STRUCT_DESC: 42-inch corrugated metal irrigation pipe through the levee, 14.2 feet below the crown. 16-inch (approximate) pipe has been sleeved through the 42-inch corrugated metal pipe (CMP), with annular space pressure grouted. Pump structure on the waterside (WS) bank, not found in 2016. Concrete surge box at the WS toe. Slide gate in a CMP riser on the WS slope. Concrete distribution box on the landside (LS) across River Road. Phone number provided is 916-802-8293. (Permit No. 1833, 1953 - Carter). [Additional Reference(s): DWR Levee Log, 2002. USACE Sacramento O&M Manual 136, March 1960 (HLM 14.55)].

Waterside view: CMP riser with slide gate and surge box

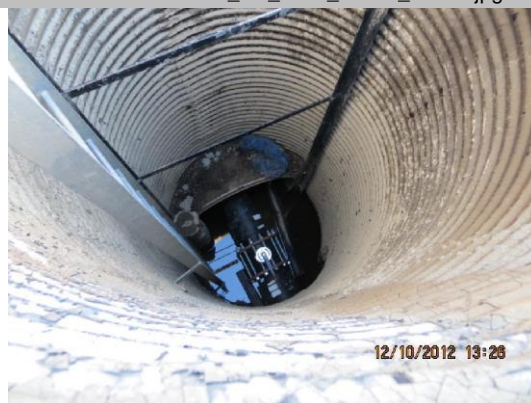
Photo 2 of 3 : UCIP_SP_2017_51753_47362.jpg

FS_ID:51753
DS_ID:17331
EP_NO: 1833
Repair Type: Non-Urgent
Crossing Status: Found
UCIP Comments: 4/20/2017 No leaky pipe marker present during this inspection but it appears that nothing has changed or was repaired since it was labled leaky in 2015. (DWR Sutter Yard- A/Freitag)10/31/2016 Leaky pipe marker was not present at inspection but nothing appears to have changed with this crossing. (DWR Sutter Yard- A/Freitag)6/15/2016 No changes made to this crossing. Leaky pipe marker still present.4/14/2016 Levee slightly caved in one side of surge box on WS4/2/2015 Leaks during high water. Distribution box plugged with cement concrete on LS. Other concrete box plugged with concrete on WS. New steel pipe (about 16 inch diameter) sleeved through CMP pipe. It is visible inside CMP riser.7/2/2014 Same as last inspection.12/19/2013 Same as last inspection.7/23/2013 Same as last inspection.
FIELD_STRUCT_DESC: 42-inch corrugated metal irrigation pipe through the levee, 14.2 feet below the crown. 16-inch (approximate) pipe has been sleeved through the 42-inch corrugated metal pipe (CMP), with annular space pressure grouted. Pump structure on the waterside (WS) bank, not found in 2016. Concrete surge box at the WS toe. Slide gate in a CMP riser on the WS slope. Concrete distribution box on the landside (LS) across River Road. Phone number provided is 916-802-8293. (Permit No. 1833, 1953 - Carter). [Additional Reference(s): DWR Levee Log, 2002. USACE Sacramento O&M Manual 136, March 1960 (HLM 14.55)].

Waterside view: new steel pipe sleeved through CMP pipe.

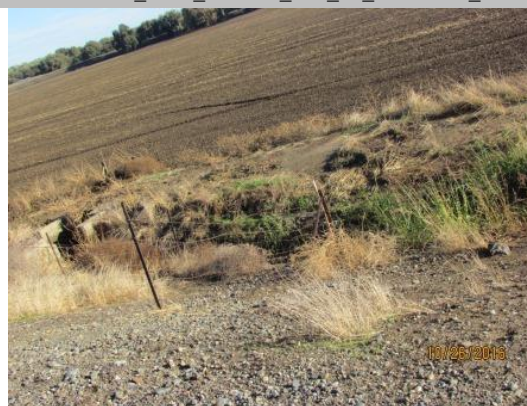
Photo 1 of 1 : SP_2017_ST0003_264_71_20170315_00018.jpg

LM Start	15.17	Rating **	M	Issue No.	71
LM End	15.48	Issue Type +	En	Location *	LS
Category	Earthen Levee			GPS Latitude/Longitude	
				Start	End
Item	Encroachments			39.330578 °	39.333842 °
				-122.018485 °	-122.022225 °
DWR ID	DWR_ST0003_01_f_2016_71				
Comment Code					
DT : Ditch					
Inspector Comment

View of a ditch along the landside toe.

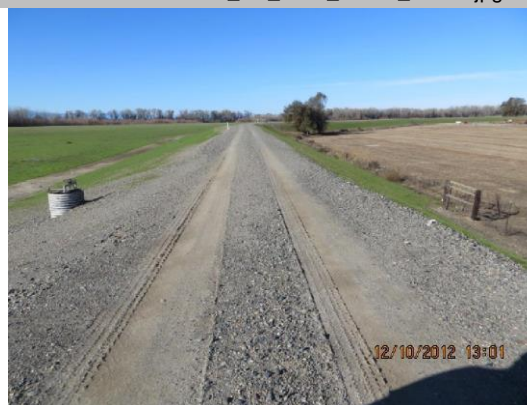
Photo 1 of 3 : UCIP_SP_2017_51755_47371.jpg

Comment Code					
Inspector Comment					
FS_ID:51755 DS_ID:17333 EP_NO: 9506 Repair Type: Non-Urgent Crossing Status: Found UCIP Comments: 4/20/2017 Both pipe ends were underwater during site visit but it appears to be in good condition. (DWR Sutter Yard-AFreitag)10/31/2016 Minor erosion caused by rain runoff starting at the top of the WS headwall. RESt of crossing appears in good condition. (DWR Sutter Yard- AFreitag)6/15/2016 Both pipe ends were underwater but appear to be in good condition.4/2/2015 Pipe and ditches were full of water. Everything seemed to be in good shape.Water full on inlet and outlet of the structure.7/2/2014 Same as last inspection.12/19/2013 Same as last inspection.7/23/2013 Same as last inspection. FIELD_STRUCT_DESC: 24-inch irrigation pipe of an unknown material through the levee, 16.5 feet below the crown. Pump in the floodway. Irrigation transfer ditch on the waterside (WS) to concrete surge box at the WS toe. Slide gates in a corrugated metal pipe (CMP) riser on the WS slope. Discharges into a concrete distribution box at the landside (LS) toe. (Automatic Board Order (ABO) issued as Permit No. 9506, 1974 - Carter). [Additional Reference(s): DWR Levee Log, 2002. USACE Sacramento O&M Manual 136, March 1960 (HLM 15.46)]. FS Date: 5/1/2017 10:38:21 AM

Crown view: overview (both sides of the levee)

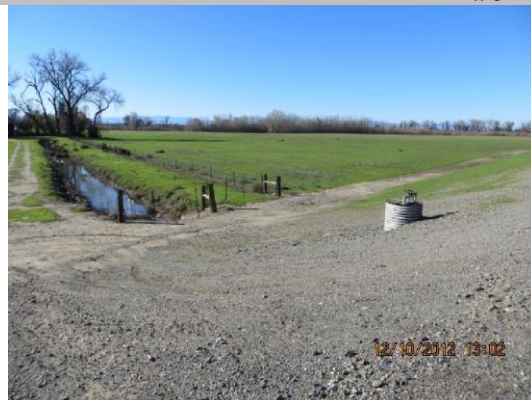
Photo 2 of 3 : UCIP_SP_2017_51755_47370.jpg

UCIP Comments: 4/20/2017 Both pipe ends were underwater during site visit but it appears to be in good condition. (DWR Sutter Yard-AFreitag)10/31/2016 Minor erosion caused by rain runoff starting at the top of the WS headwall. REst of crossing appears in good condition. (DWR Sutter Yard- AFreitag)6/15/2016 Both pipe ends were underwater but appear to be in good condition.4/2/2015 Pipe and ditches were full of water. Everything seemed to be in good shape. Water full on inlet and outlet of the structure.7/2/2014 Same as last inspection.12/19/2013 Same as last inspection.7/23/2013 Same as last inspection.

Waterside view: CMP riser, inlet box and water transfer ditch

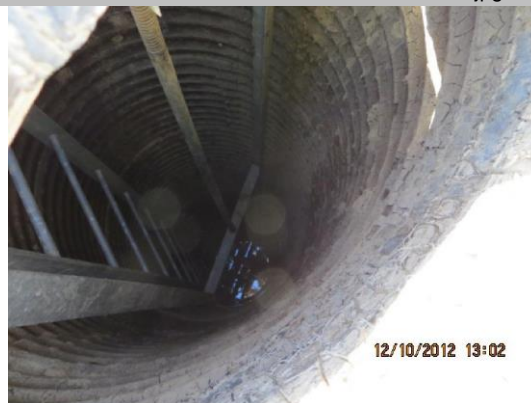
Photo 3 of 3 : UCIP_SP_2017_51755_47369.jpg

Waterside view: inside CMP riser

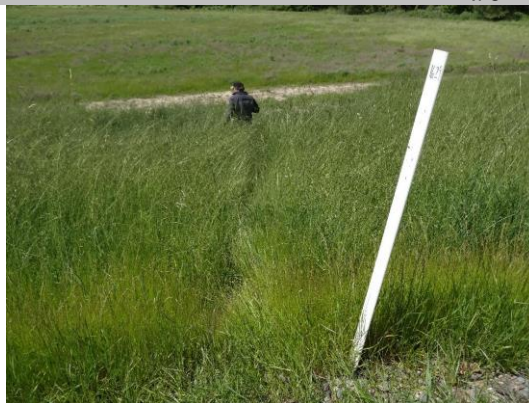
Photo 1 of 3 : UCIP_SP_2017_51759_75096.jpg

FS_ID:51759
DS_ID:17337
EP_NO: N/A
Repair Type: Non-Urgent
Crossing Status: Found
UCIP Comments: 4/20/2017 Abandoned- needs to be done so properly. (DWR Sutter Yard- AFreitag)11/1/2016 Abandoned. Pipe is buried and not visible but a white marker on WS shoulder shows its location. (DWR Sutter Yard- AFreitag)6/15/2016 Pipe was dug up and internally cleaned and camera inspected on 11/19/2015 by Nor-Cal Pipeline Services. Pipe section through the levee is 88ft long and showed signs of rusting but no holes or other deterioration was found. The WS flap gate was broken during excavation but doesnt pose an issue as the pipe was capped and reburied until further abandonment can be achieved. Unfortunately the pipe was not photographed when exposed.4/14/2016 Same as last inspection.4/2/2015 Unable to locate. Pipe has been selected to be dug up and internally camera inspected.7/2/2014 Unable to locate.12/19/2013 Unable to locate7/23/2013 Same as last inspection. Unable to locate.

View from crown down WS slope at location of crossing.

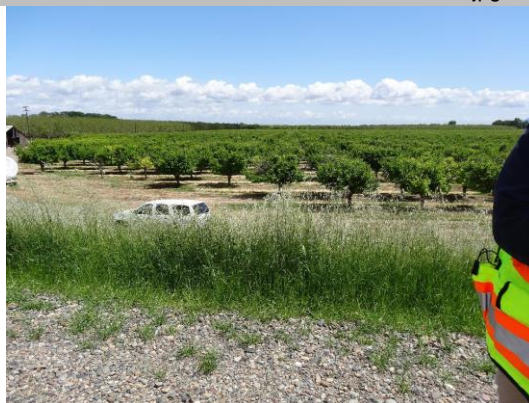
Photo 2 of 3 : UCIP_SP_2017_51759_75097.jpg

View of LS from crown at location of crossing.

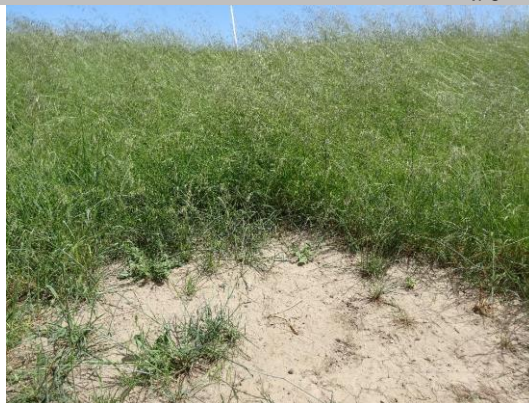
Photo 3 of 3 : UCIP_SP_2017_51759_75098.jpg

Item	DWR UCIP LMA Responsibility			39.344177 °	39.344177 °	
				-122.024300 °	-122.024300 °	
DWR ID						
Comment Code						
Inspector Comment						
FS_ID:51759 DS_ID:17337 EP_NO: N/A Repair Type: Non-Urgent Crossing Status: Found UCIP Comments: 4/20/2017 Abandoned- needs to be done so properly. (DWR Sutter Yard- A Freitag)11/1/2016 Abandoned. Pipe is buried and not visible but a white marker on WS shoulder shows its location. (DWR Sutter Yard- A Freitag)6/15/2016 Pipe was dug up and internally cleaned and camera inspected on 11/19/2015 by Nor-Cal Pipeline Services. Pipe section through the levee is 88ft long and showed signs of rusting but no holes or other deterioration was found. The WS flap gate was broken during excavation but doesnt pose an issue as the pipe was capped and reburied until further abandonment can be achieved. Unfortunately the pipe was not photographed when exposed.4/14/2016 Same as last inspection.4/2/2015 Unable to locate. Pipe has been selected to be dug up and internally camera inspected.7/2/2014 Unable to locate.12/19/2013 Unable to locate.7/23/2013 Same as last inspection. Unable to locate. FIELD_STRUCT_DESC: 42-inch corrugated metal drainage pipe through the levee, 16.5 feet below the crown. Metal flap gate on the waterside (WS) silted over. Brick "U" shaped headwall on the WS toe. [Additional Reference(s): DWR Levee Log, 2002. USACE Sacramento O&M Manual 136, March 1960 (HLM 16.29)]. FS Date: 5/1/2017 10:41:07 AM

Looking up WS slope: bare spot where pipe was previously excavated, video inspected, and backfilled.

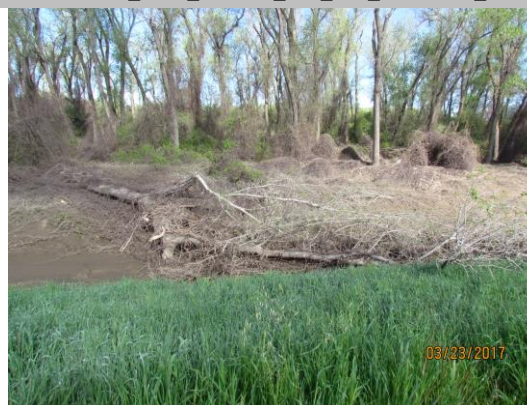
Photo 1 of 1 : SP_2017_ST0003_264_127_20170329_00186.jpg

LM Start	16.53	Rating **	M	Issue No.	127
LM End	16.53	Issue Type +	En	Location *	WS
Category	Earthen Levee			GPS Latitude/Longitude	
				Start	End
Item	Encroachments			39.346822 °	39.346822 °
				-122.021678 °	-122.021678 °
DWR ID	DWR_ST0003_01_s _ 2017_127				
Comment Code					
TR : Tree or limb					
Inspector Comment					
Remove the tree from the waterside slope and toe.

View of the tree on the waterside slope and toe.

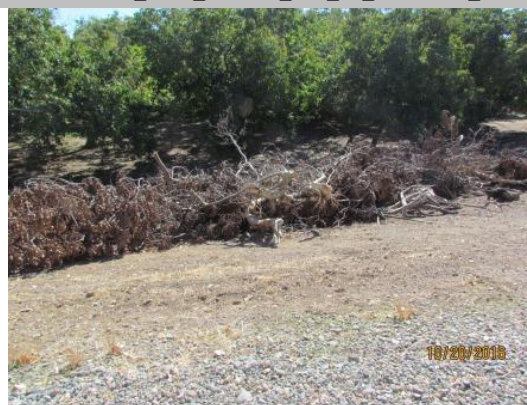
Photo 1 of 1 : SP_2017_ST0003_264_68_20170315_00017.jpg

LM Start	16.96	Rating **	M	Issue No.	68
LM End	16.96	Issue Type +	En	Location *	LS
Category	Earthen Levee			GPS Latitude/Longitude	
				Start	End
Item	Encroachments			39.347312 °	39.347312 °
				-122.015137 °	-122.015137 °
DWR ID	DWR_ST0003_01_f_2016_68				
Comment Code					
PR : Prunings					
Inspector Comment					
Remove prunings from the landside toe.

View of the prunings along the landside toe.

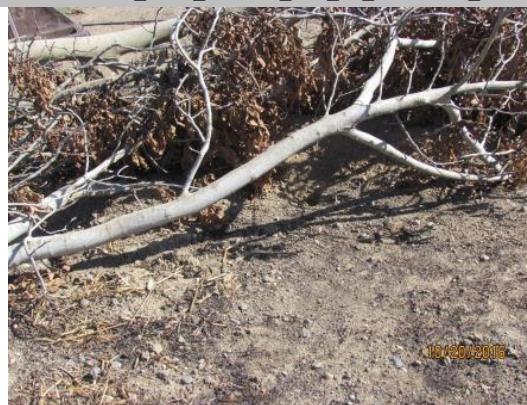
Photo 1 of 1 : SP_2017_ST0003_264_67_20170315_00016.jpg

LM Start	17.29	Rating **	U	Issue No.	67
LM End	17.29	Issue Type +	Ma	Location *	LS
Category	Earthen Levee			GPS Latitude/Longitude	
				Start	End
Item	Animal Control			39.349450 °	39.349450 °
				-122.009988 °	-122.009988 °
DWR ID	DWR_ST0003_01_f_2016_67				
Comment Code					
A3 : No rodents visible, but rodent burrows visible; need to backfill and compact or grout burrows.					
Inspector Comment

View of the rodent holes along the landside slope under the tree limb.

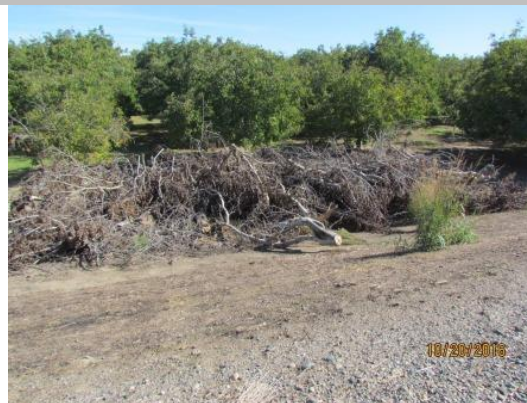
Photo 1 of 1 : SP_2017_ST0003_264_66_20170315_00015.jpg

LM Start	17.42	Rating **	M	Issue No.	66
LM End	17.42	Issue Type +	En	Location *	LS
Category	Earthen Levee			GPS Latitude/Longitude	
				Start	End
Item	Encroachments			39.351322 °	39.351322 °
				-122.009348 °	-122.009348 °
DWR ID	DWR_ST0003_01_f_2016_66				
Comment Code					
PR : Prunings					
Inspector Comment					
Remove prunings from the landside toe.

View of the prunings along the landside toe.

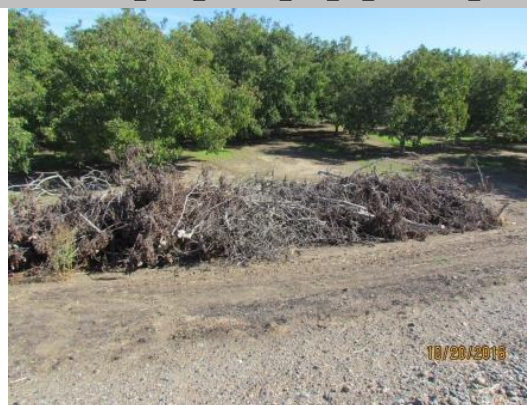
Photo 1 of 1 : SP_2017_ST0003_264_65_20170315_00014.jpg

LM Start	17.51	Rating **	M	Issue No.	65
LM End	17.51	Issue Type +	En	Location *	LS
Category	Earthen Levee			GPS Latitude/Longitude	
				Start	End
Item	Encroachments			39.352615 °	39.352615 °
				-122.009247 °	-122.009247 °
DWR ID	DWR_ST0003_01_f_2016_65				
Comment Code					
PR : Prunings					
Inspector Comment					
Remove prunings from the landside toe.

View of the prunings along the landside toe.

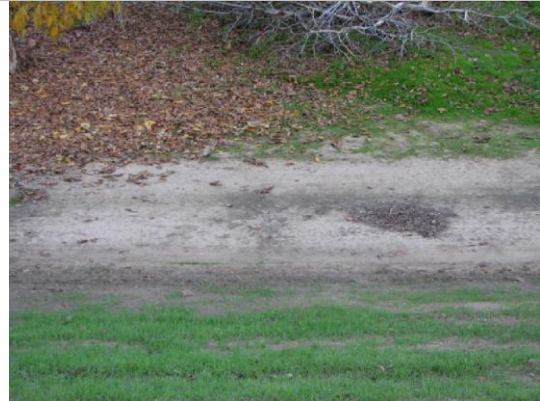
Photo 1 of 3 : UCIP_SP_2017_51762_47384.jpg

FS_ID:51762
DS_ID:17329
EP_NO: N/A
Repair Type: Non-Urgent
Crossing Status: Found
UCIP Comments: 4/20/2017 Abandoned- needs to be done properly. Pipe had a small leak during high water and is believed to be caused by the screw gate not being fully closed before it was reburied after its internal inspection. (DWR Sutter Yard- A Freitag)11/1/2016 Abandoned. (DWR Sutter Yard- A Freitag)6/15/2016 Pipe was dug up and internally cleaned and camera inspected on 11/18/2015 by Nor-Cal Pipeline Services. Pipe section through levee is about 93.8ft long. Inspection showed signs of rusting but no holes or other deterioration was found. WS end and slidegate were photographed, LS end was not. After the inspection pipe ends were capped and reburied until further abandonment can be achieved.4/2/2015 WS pipe end was dug up in preparation for internal camera inspection. Only steel slide gate structure found on waterside.7/2/2014 Same as last inspection.12/19/2013 Same as last inspection.7/24/2013 Same as last inspection.

Landside view: overview. No pipe found.

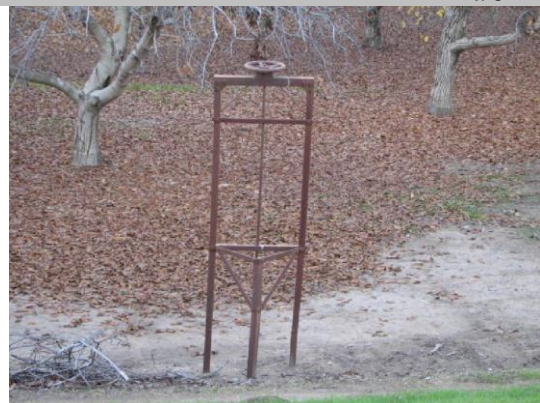
Photo 2 of 3 : UCIP_SP_2017_51762_47386.jpg

Waterside view: slide gate steel structure

Comment Code					
Inspector Comment					
FS_ID:51762 DS_ID:17329 EP_NO: N/A Repair Type: Non-Urgent Crossing Status: Found UCIP Comments: 4/20/2017 Abandoned- needs to be done properly. Pipe had a small leak during high water and is believed to be caused by the screw gate not being fully closed before it was reburied after its internal inspection. (DWR Sutter Yard- AFreitag)11/1/2016 Abandoned. (DWR Sutter Yard- AFreitag)6/15/2016 Pipe was dug up and internally cleaned and camera inspected on 11/18/2015 by Nor-Cal Pipeline Services. Pipe section through levee is about 93.8ft long. Inspection showed signs of rusting but no holes or other deterioration was found. WS end and slidegate were photographed, LS end was not. After the inspection pipe ends were capped and reburied until further abandonment can be achieved.4/2/2015 WS pipe end was dug up in preparation for internal camera inspection. Only steel slide gate structure found on waterside.7/2/2014 Same as last inspection.12/19/2013 Same as last inspection.7/24/2013 Same as last inspection. FIELD_STRUCT_DESC: *ABANDONED* 24-inch corrugated metal drainage pipe through the levee, 15.8 feet below the crown. Slide gate on the waterside (WS) end. Both pipe ends are silted over. [Additional Reference(s): DWR Levee Log, 2002. USACE Sacramento O&M Manual 136, March 1960 (HLM 17.6)]. FS Date: 5/1/2017 10:45:36 AM

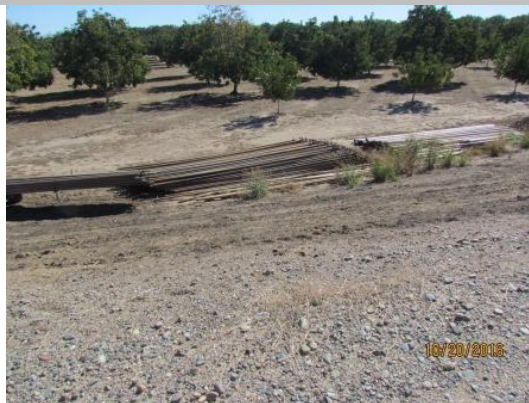
Photo 1 of 1 : SP_2017_ST0003_264_63_20170315_00013.jpg

LM Start	17.97	Rating **	M	Issue No.	63
LM End	17.97	Issue Type +	En	Location *	LS
Category	Earthen Levee			GPS Latitude/Longitude	
				Start	End
Item	Encroachments			39.358920 °	39.358920 °
				-122.007537 °	-122.007537 °
DWR ID	DWR_ST0003_01_f_2016_63				
Comment Code					
EQ : Equipment					
Inspector Comment

View of the ag equipment along the landside toe.

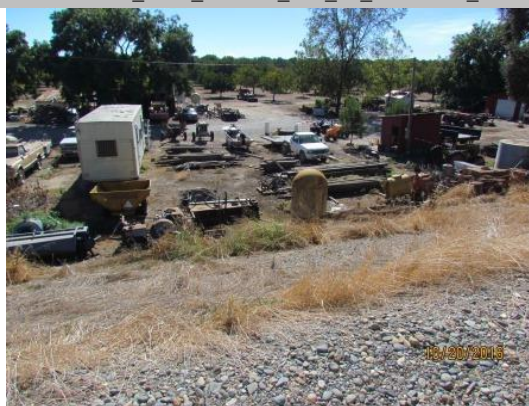
Photo 1 of 1 : SP_2017_ST0003_264_61_20170315_00012.jpg

LM Start	18.15	Rating **	M	Issue No.	61
LM End	18.15	Issue Type +	En	Location *	LS
Category	Earthen Levee			GPS Latitude/Longitude	
				Start	End
Item	Encroachments			39.360038 °	39.360038 °
				-122.004485 °	-122.004485 °
DWR ID	DWR_ST0003_01_f_2016_61				
Comment Code					
EQ : Equipment					
Inspector Comment

View of the ag equipment along the landside toe.

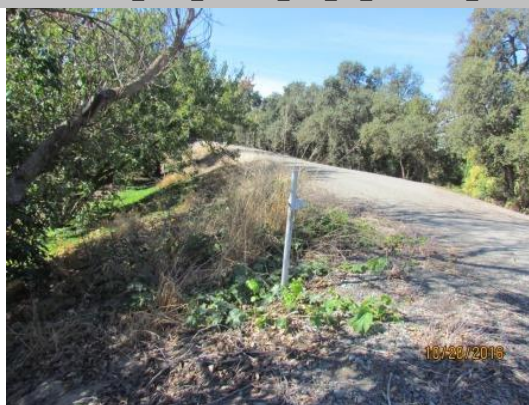
Photo 1 of 1 : SP_2017_ST0003_264_60_20170315_00011.jpg

LM Start	18.18	Rating **	M	Issue No.	60
LM End	18.18	Issue Type +	Ma	Location *	LS
Category	Earthen Levee			GPS Latitude/Longitude	
				Start	End
Item	Vegetation			39.360018 °	39.360018 °
				-122.003827 °	-122.003827 °
DWR ID	DWR_ST0003_01_f_2016_60				
Comment Code					
V1 : Control annual grass and weeds on the levee slopes and easements.					
Inspector Comment

View of the grape vine and annual grass along the landside slope.

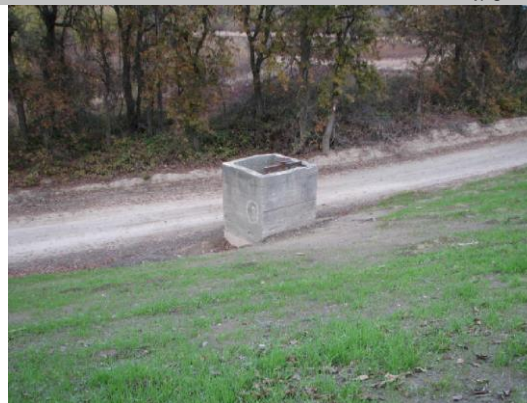
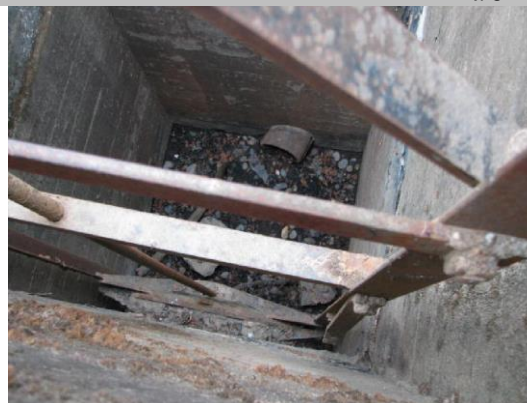
FS_ID:51766
DS_ID:17343
EP_NO: 9502
Repair Type: Non-Urgent
Crossing Status: Found
UCIP Comments: 4/20/2017 Abandoned- needs to be done properly. (DWR Sutter Yard- A Freitag) 11/1/2016 Abandoned. (DWR Sutter Yard- A Freitag) 6/3/2016 Abandoned crossing. 4/2/2015 Same as last inspection. Vertical pump on bank not found as bank is not accessible. An abandoned electrical switch found on waterside. Landside distribution box is filled with debris and soil. Crossing appears abandoned and should be verified as having been done so properly.

7/2/2014 Same as last inspection. 12/19/2013 Same as last inspection. 7/24/2013 Same as last inspection.
FIELD_STRUCT_DESC: *ABANDONED* 36-inch corrugated metal irrigation pipe through the levee, 18 feet below the crown. Vertical pump on the waterside (WS) bank, not found in 2015. Slide gate in a concrete box on the WS toe. Pipe discharges into a concrete distribution box on the landside (LS) toe. Pole on the WS shoulder and an abandoned electrical switch found on the WS. (Automatic Board Order (ABO) issued as Permit No. 9502, 1974 - Coffman). (Additional Related Permit(s): Permit No. 11540, 1976 - Wilearlee Walnuts). [Additional Reference(s): DWR Levee Log, 2002. USACE Sacramento O&M Manual 136, March 1960 (HLM 18.22)].
FS Date: 5/1/2017 10:49:09 AM

LM Start	18.19	Rating **	M	Issue No.	185 (cont)
LM End	18.19	Issue Type +	En	Location *	LS

Waterside view: overview of gate riser

Waterside view: inside gate riser

Waterside view: concrete gate riser

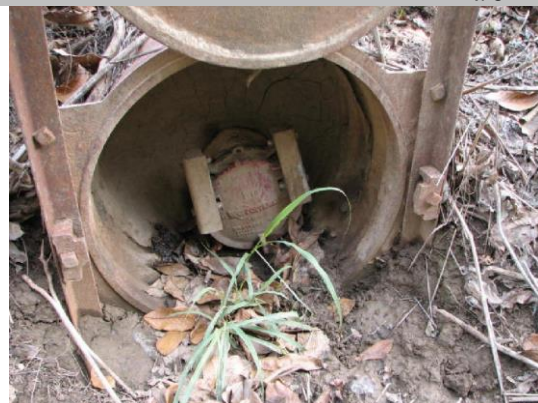
LM Start	18.70	Rating **	A/W	Issue No.	188 (cont)
LM End	18.70	Issue Type +	Ma	Location *	LS

Waterside view: overview of slide gate structure

Waterside view: 8-inch pipe inside 24-inch CMP

FIELD_STRUCT_DESC: 24-inch corrugated metal drainage pipe through the levee, 19 feet below the crown. 8-inch steel pipe sleeved through the 24-inch pipe. Annular space cement grouted. Slide gate at the waterside (WS) toe. Concrete inlet box on the landside (LS). (Automatic Board Order (ABO) issued as Permit No. 9503, 1974 - Baird). [Additional Reference(s): DWR Levee Log, 2002. USACE Sacramento O&M Manual 136, March 1960 (HLM 18.74)].
FS Date: 5/1/2017 10:53:44 AM

Waterside view: 8-inch pipe and drain gate

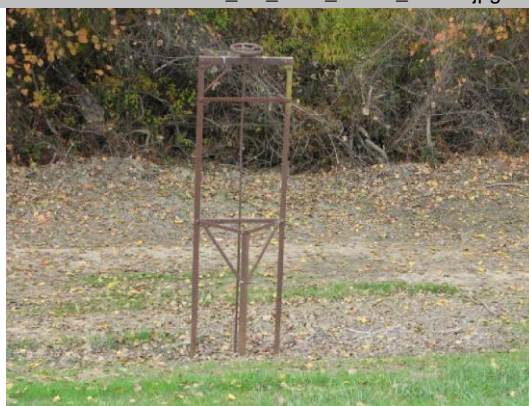
FS_ID:51773
DS_ID:17347
EP_NO: N/A
Repair Type: No Action Needed
Crossing Status: Found
UCIP Comments: 4/20/2017 Abandoned- plugged. (DWR Sutter Yard-AFreitag)11/1/2016 Abandoned/plugged. (DWR Sutter Yard-AFreitag)6/16/2016 Internal camera inspection was done on 11/19/2015 by Nor-Cal Pipeline Servies. Pipe was inspected starting from the WS end and inspected upto the grout plug that is 13.7ft into the pipe. Pipe was then capped and reburied until further abandonment can be achieved.4/2/2015 WS end of pipe was dug up in preparation for internal camera inspection. Only steel slide gate structure found on WS.7/2/2014 Same as last inspection.12/19/2013 Same as last inspection.7/24/2013 Same as last inspection.
FIELD_STRUCT_DESC: *ABANDONED* 36-inch corrugated metal drainage pipe through the levee, 21.7 feet below the crown. Slide gate at the waterside (WS) toe. Pipe grouted on the WS end. [Additional Reference(s): DWR Levee Log, 2002. USACE Sacramento O&M Manual 136, March 1960 (HLM 19.24)].

LM Start	19.19	Rating **	A/W	Issue No.	189 (cont)
LM End	19.19	Issue Type +	Ma	Location *	LS

Waterside view: overview of abandoned slide gate structure

Landside view: overview (no pipes)

WS pipe end and screw gate

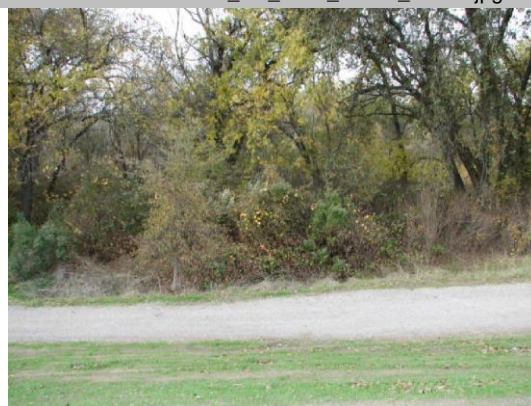
Photo 1 of 3 : UCIP_SP_2017_51775_47449.jpg

Comment Code					
Inspector Comment					
FS_ID:51775 DS_ID:17487 EP_NO: N/A Repair Type: Non-Urgent Crossing Status: Found UCIP Comments: 4/20/2017 Abandoned- needs to be done so properly. (DWR Sutter Yard- A Freitag)11/1/2016 Abandoned.(DWR Sutter Yard- A Freitag)6/3/2016 Abandoned crossing.4/2/2015 Same as last inspection. Slide Gate WS not found. An abandoned pump and steel pipe found on WS. A 6 ft x 8 ft concrete distribution box with a CMP found on LS. Box filled with soil. An abandoned crossing.7/2/2014 Same as last inspection.12/19/2013 Same as last inspection.7/24/2013 Same as last inspection. FIELD_STRUCT_DESC: *ABANDONED* 36-inch corrugated metal drainage pipe through the levee, invert 21.7 feet below the crown. Abandoned pump and steel pipe found on the waterside (WS). 6 foot by 8 foot concrete distribution box with the 36-inch corrugated metal pipe found on the landside (LS). [Additional Reference(s): USACE Sacramento O&M Manual 136, March 1960 (HLM 19.61)]. FS Date: 5/1/2017 10:56:50 AM

LM Start	19.55	Rating **	M	Issue No.	190 (cont)
LM End	19.55	Issue Type +	Ma	Location *	LS

Waterside view: overview

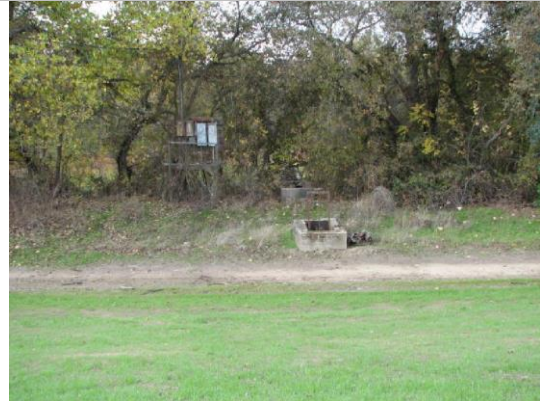
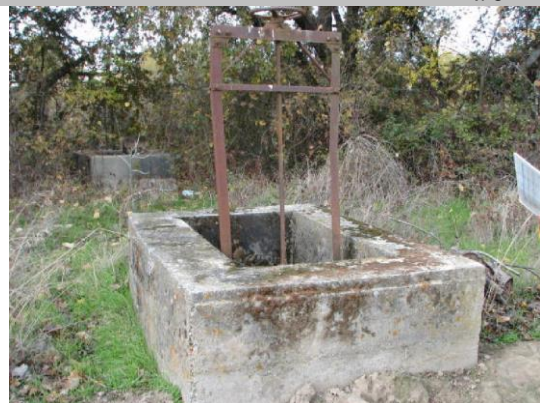
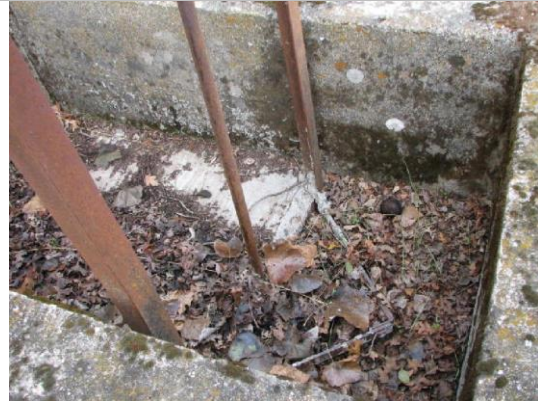
FS_ID:51776
DS_ID:17370
EP_NO: 9496
Repair Type: Non-Urgent
Crossing Status: Found
UCIP Comments: 4/20/2017 Abandoned- needs to be done properly. (DWR Sutter Yard- A Freitag) 11/1/2016 Abandoned. (DWR Sutter Yard- A Freitag) 6/3/2016 Abandoned crossing 4/2/2015 Same as last inspection. Only one pump found on WS. An abandoned surge box found on WS and pipe is grouted with cement. Two 16-inch steel pipe found on pump station along with two electrical conduits. A concrete distribution box found on LS with 20-inch CMP. Appears abandoned crossing. 7/2/2014 Same as last inspection. 12/19/2013 Same as last inspection. 7/24/2013 Same as last inspection.
FIELD_STRUCT_DESC: *ABANDONED* 20-inch corrugated metal irrigation pipe through the levee, 19.8 feet below the crown. (Not 24-inch pipe, as stated in the O&M Manual, Automatic Board Order, and Levee Log). Two vertical pumps on a pile structure on the waterside (WS) bank (one pump found in 2015). Slide gate in a concrete surge box on the waterside (WS) berm. Discharges into a concrete distribution box on the landside (LS) across the county road. Switch board on the platform on the WS bank. (Automatic Board Order (ABO) issued as Permit No. 9496, 1974 - Womble). [Additional Reference(s): DWR Levee Log, 2002. USACE Sacramento O&M Manual 136, March 1960 (HLM 20.05)].

LM Start	19.97	Rating **	M	Issue No.	191 (cont)
LM End	19.97	Issue Type +	En	Location *	LS

Waterside view: overview

Waterside view: gate riser with slide gate

Waterside view: abandoned pipe with cement grouting

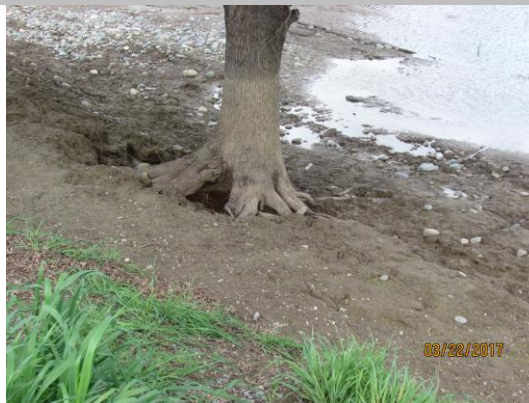
Photo 1 of 1 : SP_2017_ST0003_265_6_20170329_00007.jpg

LM Start	0.02	Rating **	U	Issue No.	6
LM End	0.02	Issue Type +	Ma	Location *	WS
Category	Earthen Levee			GPS Latitude/Longitude	
				Start	End
Item	Erosion / Bank Caving			39.232053 °	39.232053 °
				-121.995572 °	-121.995572 °
DWR ID	DWR_ST0003_02_s_2017_6				
Comment Code					
E2 : Schedule repair of erosion site prior to the next inspection.					
Inspector Comment					
Repair the erosion along the toe of the levee.

View of the erosion along the oak tree.

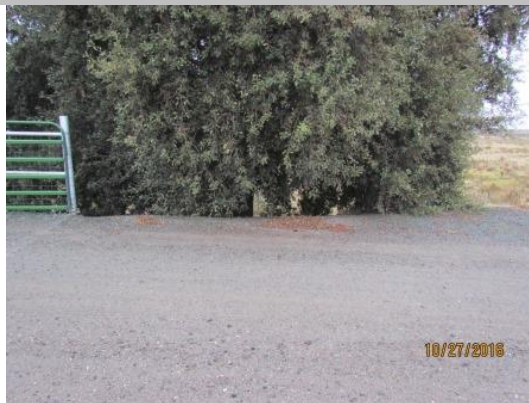
Photo 1 of 1 : SP_2017_ST0003_265_3_20170315_00001.jpg

LM Start	0.02	Rating **	M	Issue No.	3
LM End	0.02	Issue Type +	Ma	Location *	WS
Category	Earthen Levee			GPS Latitude/Longitude	
				Start	End
Item	Trim / Thin Trees			39.232080 °	39.232080 °
				-121.995502 °	-121.995502 °
DWR ID	DWR_ST0003_02_f_2016_3				
Comment Code					
T1 : Trim trees to at least five feet above ground level.					
Inspector Comment

View of the overgrown tree along the waterside slope.

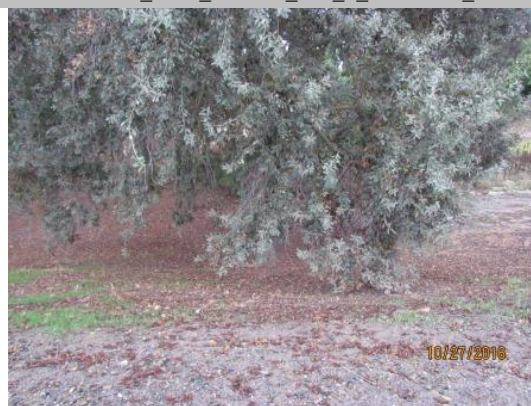
Photo 1 of 1 : SP_2017_ST0003_265_5_20170315_00003.jpg

LM Start	0.09	Rating **	M	Issue No.	5
LM End	0.09	Issue Type +	Ma	Location *	LS
Category	Earthen Levee			GPS Latitude/Longitude	
				Start	End
Item	Trim / Thin Trees			39.231782 °	39.231782 °
				-121.994183 °	-121.994183 °
DWR ID	DWR_ST0003_02_f_2016_5				
Comment Code					
T1 : Trim trees to at least five feet above ground level.					
Inspector Comment

View of the overgrown tree along the landside toe.

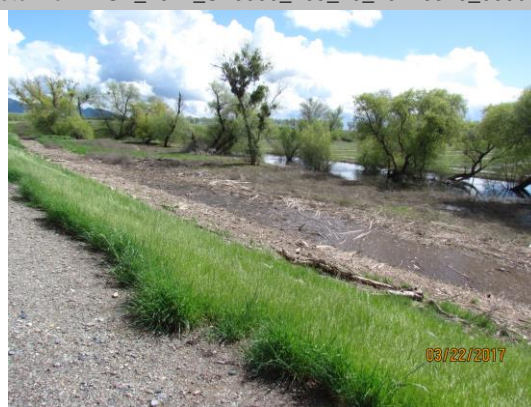
Photo 1 of 1 : SP_2017_ST0003_265_10_20170329_00008.jpg

LM Start	0.21	Rating **	M	Issue No.	10
LM End	1.02	Issue Type +	En	Location *	LS
Category	Earthen Levee			GPS Latitude/Longitude	
				Start	End
Item	Encroachments			39.231342 °	39.231432 °
				-121.992158 °	-121.976993 °
DWR ID	DWR_ST0003_02_s_2017_10				
Comment Code					
DE : Debris					
Inspector Comment					
Remove the debris from the landside slope and toe.

View of the debris along the landside slope and toe.

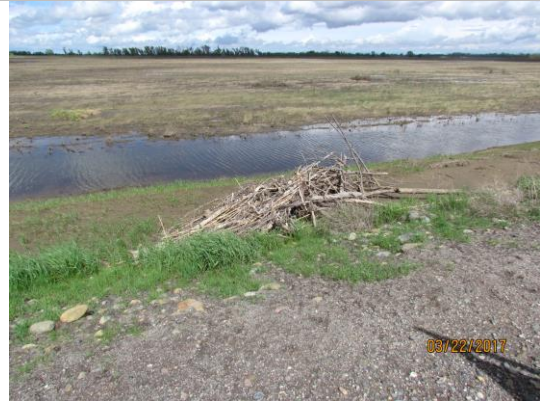
Photo 1 of 1 : SP_2017_ST0003_265_9_20170329_00010.jpg

LM Start	0.73	Rating **	M	Issue No.	9
LM End	0.73	Issue Type +	En	Location *	WS
Category	Earthen Levee			GPS Latitude/Longitude	
				Start	End
Item	Encroachments			39.231430 °	39.231430 °
				-121.982472 °	-121.982472 °
DWR ID	DWR_ST0003_02_s_2017_9				
Comment Code					
DE : Debris					
Inspector Comment					
Remove the debris from the waterside toe.

View of the debris along the waterside toe.

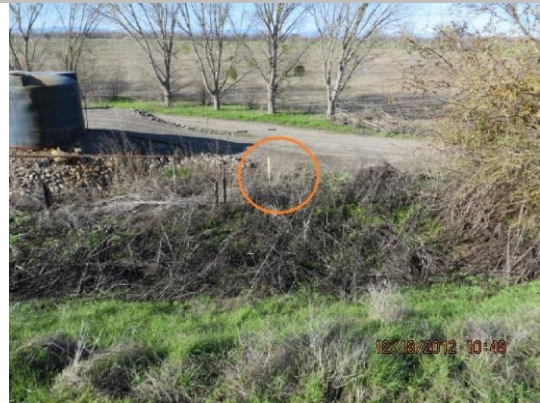
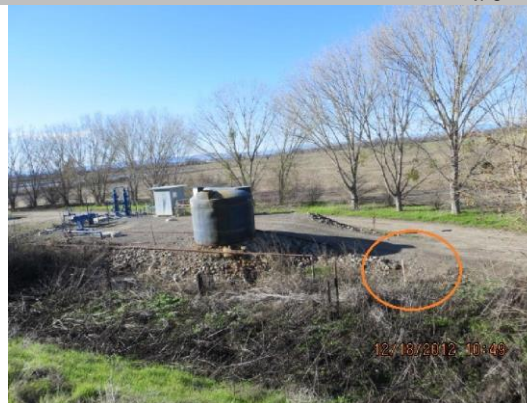
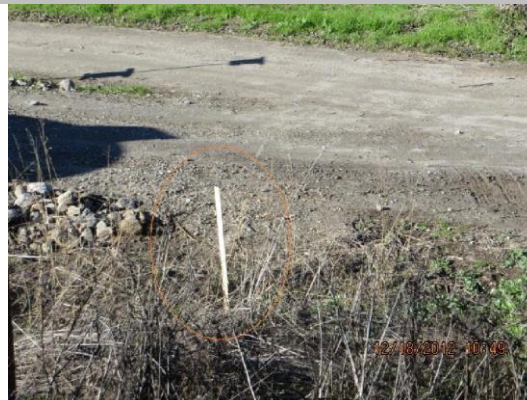
LM Start	1.20	Rating **	M	Issue No.	12
LM End	1.20	Issue Type +	En	Location *	WS
Category	Supplemental			GPS Latitude/Longitude	
				Start	End
Item	DWR UCIP Field Study			39.229526 °	39.229526 °
				-121.975686 °	-121.975686 °
DWR ID

Comment Code					
Inspector Comment					
FS_ID:49161 DS_ID:17531 EP_NO: 13534 Repair Type: Non-Urgent Crossing Status: Indicator Found UCIP Comments: 6/3/2016 Crossing appears to be in good condition.4/6/2015 Same as last inspection. May need to add more substantial gasoline markers.7/7/2014 Same as last inspection.12/19/2013 Same as last inspection.7/22/2013 Same as last inspection. FIELD_STRUCT_DESC: 2.5-inch asphalt coated steel gas pipeline through the levee, 2.5 feet below the crown. A gas line marker found on the landside (LS). (Permit No. 13534, 1982 - Texaco, Incorporated). [Additional Reference(s): DWR Levee Log, 2002]. FS Date: 6/16/2016 10:00:15 AM

Landside view: overview gasline indicator

Landside view: overview gasoline indicator

Landside view: gasoline indicator

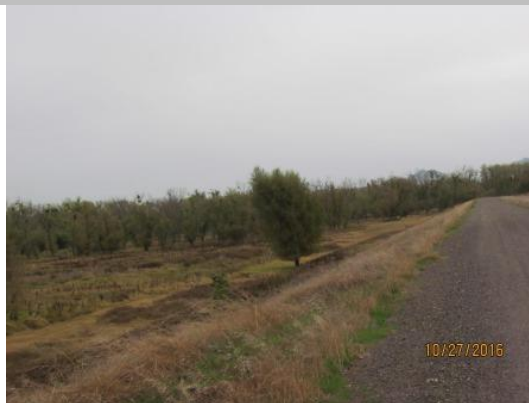
Photo 1 of 1 : SP_2017_ST0003_265_4_20170315_00002.jpg

LM Start	2.02	Rating **	M	Issue No.	4
LM End	2.19	Issue Type +	Ma	Location *	WS
Category	Earthen Levee			GPS Latitude/Longitude	
				Start	End
Item	Vegetation			39.227865 °	39.227868 °
				-121.962233 °	-121.959095 °
DWR ID	DWR_ST0003_02_f_2016_4				
Comment Code					
V1 : Control annual grass and weeds on the levee slopes and easements.					
Inspector Comment

View of the waterside vegetation.

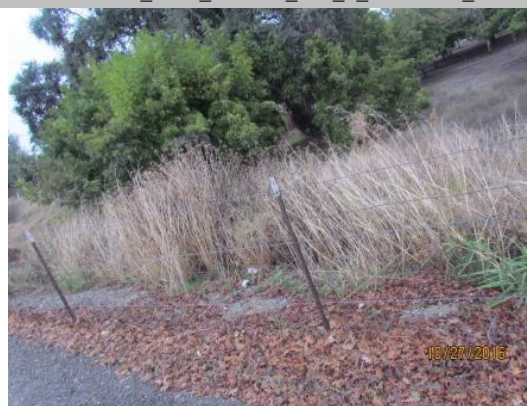
Photo 1 of 1 : SP_2017_ST0003_266_1_20170315_00001.jpg

LM Start	0.01	Rating **	M	Issue No.	1
LM End	0.04	Issue Type +	Ma	Location *	LS
Category	Earthen Levee			GPS Latitude/Longitude	
				Start	End
Item	Vegetation			39.236627 °	39.236552 °
				-121.993928 °	-121.993417 °
DWR ID	DWR_ST0003_03_f_2016_1				
Comment Code					
V1 : Control annual grass and weeds on the levee slopes and easements.					
Inspector Comment

View of the landside vegetation.

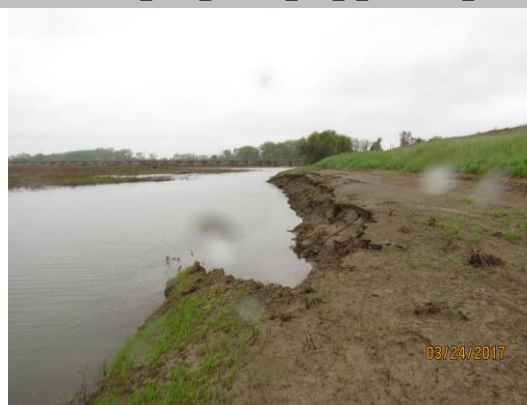
Photo 1 of 1 : SP_2017_ST0003_266_9_20170329_00008.jpg

LM Start	0.02	Rating **	U	Issue No.	9
LM End	1.04	Issue Type +	Ma	Location *	WS
Category	Earthen Levee			GPS Latitude/Longitude	
				Start	End
Item	Slope Stability			39.236668 °	39.239502 °
				-121.993822 °	-121.975718 °
DWR ID	DWR_ST0003_03_s_2017_9				
Comment Code					
S1 : Repair slope instability.					
Inspector Comment					
Repair the erosion along the waterside slope and toe.

View of the erosion along the waterside slope and toe.

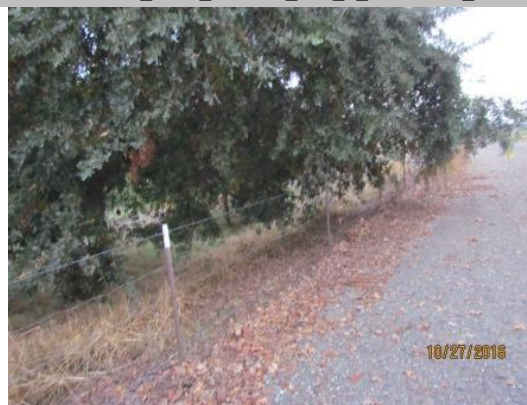
Photo 1 of 1 : SP_2017_ST0003_266_3_20170315_00002.jpg

LM Start	0.03	Rating **	M	Issue No.	3	
LM End	0.03	Issue Type +	Ma	Location *	LS	
Category	Earthen Levee			GPS Latitude/Longitude		
				Start		End
Item	Trim / Thin Trees			39.236542 °		39.236542 °
				-121.993557 °		-121.993557 °
DWR ID	DWR_ST0003_03_f_2016_3					
Comment Code						
T1 : Trim trees to at least five feet above ground level.						
Inspector Comment

View of a tree along the landside slope.

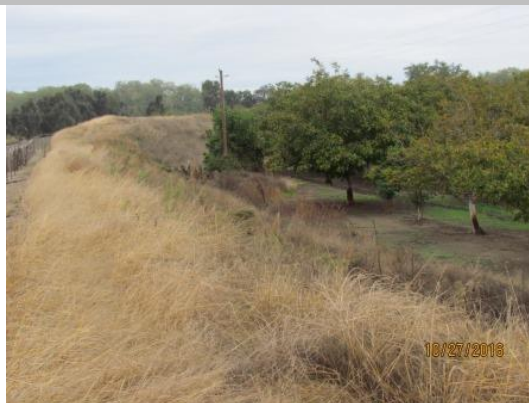
Photo 1 of 1 : SP_2017_ST0003_266_8_20170315_00007.jpg

LM Start	0.19	Rating **	M	Issue No.	8
LM End	0.24	Issue Type +	Ma	Location *	LS
Category	Earthen Levee			GPS Latitude/Longitude	
				Start	End
Item	Vegetation			39.236157 °	39.236147 °
				-121.990713 °	-121.989762 °
DWR ID	DWR_ST0003_03_f_2016_8				
Comment Code					
V1 : Control annual grass and weeds on the levee slopes and easements.					
Inspector Comment

View of the landside vegetation.

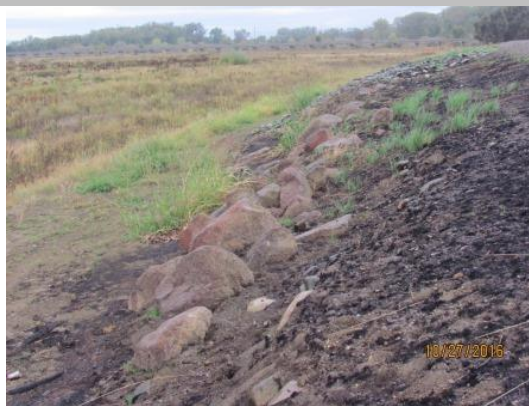
Photo 1 of 1 : SP_2017_ST0003_266_7_20170315_00006.jpg

LM Start	0.25	Rating **	M	Issue No.	7
LM End	0.25	Issue Type +	Ma	Location *	WS
Category	Earthen Levee			GPS Latitude/Longitude	
				Start	End
Item	Erosion / Bank Caving			39.236155 °	39.236155 °
				-121.989572 °	-121.989572 °
DWR ID	DWR_ST0003_03_f_2016_7				
Comment Code					
E2 : Schedule repair of erosion site prior to the next inspection.					
Inspector Comment

View of the erosion along the waterside slope.

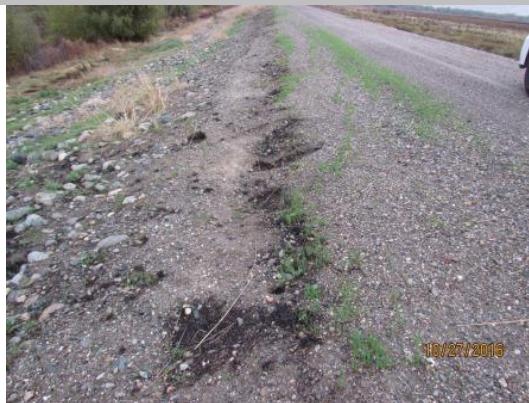
Photo 1 of 1 : SP_2017_ST0003_266_4_20170315_00003.jpg

LM Start	0.56	Rating **	M	Issue No.	4
LM End	0.56	Issue Type +	Ma	Location *	LS
Category	Earthen Levee			GPS Latitude/Longitude	
				Start	End
Item	Slope Stability			39.237220 °	39.237220 °
				-121.983908 °	-121.983908 °
DWR ID	DWR_ST0003_03_f_2016_4				
Comment Code					
S1 : Repair slope instability.					
Inspector Comment					
Repair the minor sinkholes along the landside crown

View of the slope instability along the landside slope.

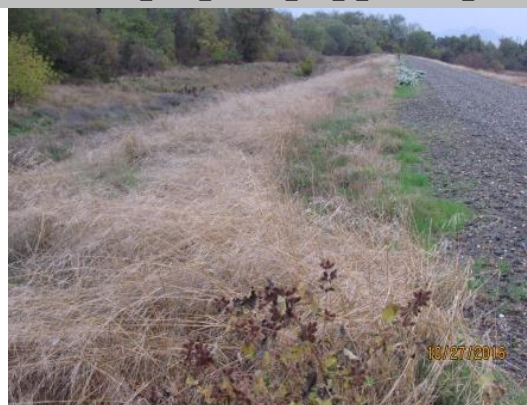
Photo 1 of 1 : SP_2017_ST0003_266_5_20170315_00004.jpg

LM Start	2.04	Rating **	M	Issue No.	5
LM End	2.29	Issue Type +	Ma	Location *	LS
Category	Earthen Levee			GPS Latitude/Longitude	
				Start	End
Item	Vegetation			39.244948 °	39.244898 °
				-121.963805 °	-121.959117 °
DWR ID	DWR_ST0003_03_f_2016_5				
Comment Code					
V1 : Control annual grass and weeds on the levee slopes and easements.					
Inspector Comment

View of the landside vegetation.

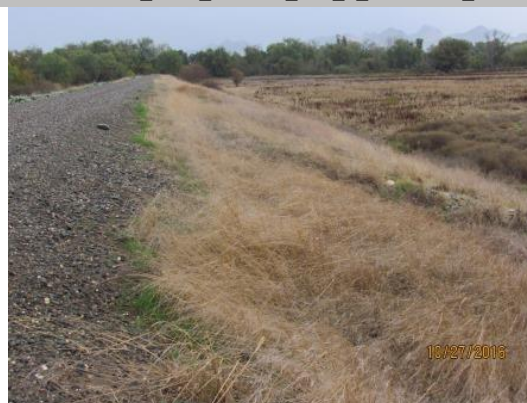
Photo 1 of 1 : SP_2017_ST0003_266_6_20170315_00005.jpg

LM Start	2.04	Rating **	M	Issue No.	6
LM End	2.29	Issue Type +	Ma	Location *	WS
Category	Earthen Levee			GPS Latitude/Longitude	
				Start	End
Item	Vegetation			39.244923 °	39.244898 °
				-121.963775 °	-121.959117 °
DWR ID	DWR_ST0003_03_f_2016_6				
Comment Code					
V1 : Control annual grass and weeds on the levee slopes and easements.					
Inspector Comment

View of the waterside vegetation.

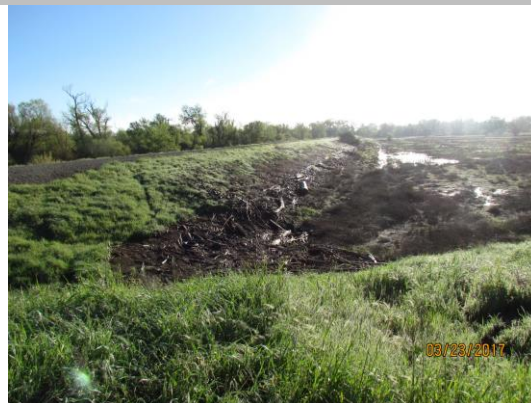
Photo 1 of 1 : SP_2017_ST0003_266_11_20170329_00009.jpg

LM Start	2.04	Rating **	M	Issue No.	11
LM End	2.20	Issue Type +	En	Location *	WS
Category	Earthen Levee			GPS Latitude/Longitude	
				Start	End
Item	Encroachments			39.244882 °	39.244908 °
				-121.963752 °	-121.960648 °
DWR ID	DWR_ST0003_03_s_2017_11				
Comment Code					
DE : Debris					
Inspector Comment					
Remove the debris from the waterside slope and toe.

View of the debris along the waterside slope and toe.

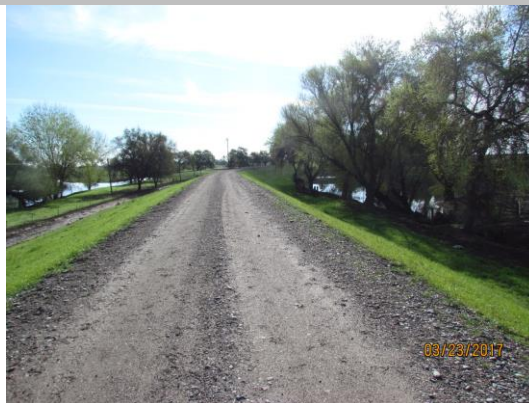
Photo 1 of 1 : SP_2017_ST0003_267_1_20170329_00001.jpg

LM Start	0.05	Rating **	A	Issue No.	1
LM End	0.05	Issue Type +	Ma	Location *	LS
Category	Earthen Levee			GPS Latitude/Longitude	
				Start	End
Item	Vegetation			39.338027 °	39.338027 °
				-122.021193 °	-122.021193 °
DWR ID	DWR_ST0003_04_s_2017_1				
Comment Code					
V1 : Control annual grass and weeds on the levee slopes and easements.					
Inspector Comment					
There is native vegetation on both slopes.

View of native vegetation on both slopes.

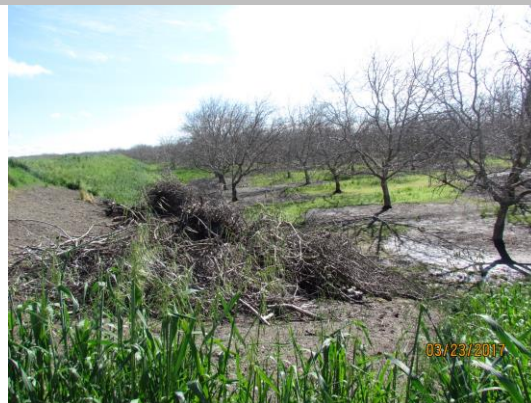
Photo 1 of 1 : SP_2017_ST0003_268_2_20170329_00002.jpg

LM Start	0.01	Rating **	M	Issue No.	2
LM End	0.01	Issue Type +	En	Location *	LS
Category	Earthen Levee			GPS Latitude/Longitude	
				Start	End
Item	Encroachments			39.347143 °	39.347143 °
				-122.015400 °	-122.015400 °
DWR ID	DWR_ST0003_05_s_2017_2				
Comment Code					
PR : Prunings					
Inspector Comment					
Remove the prunings from the landside toe.

View of prunings along the landside toe.
